Blackwood Creek Stream Channel Restoration

Reach 1 First Year Post Project Performance Monitoring

USDA Forest Service

December 2013

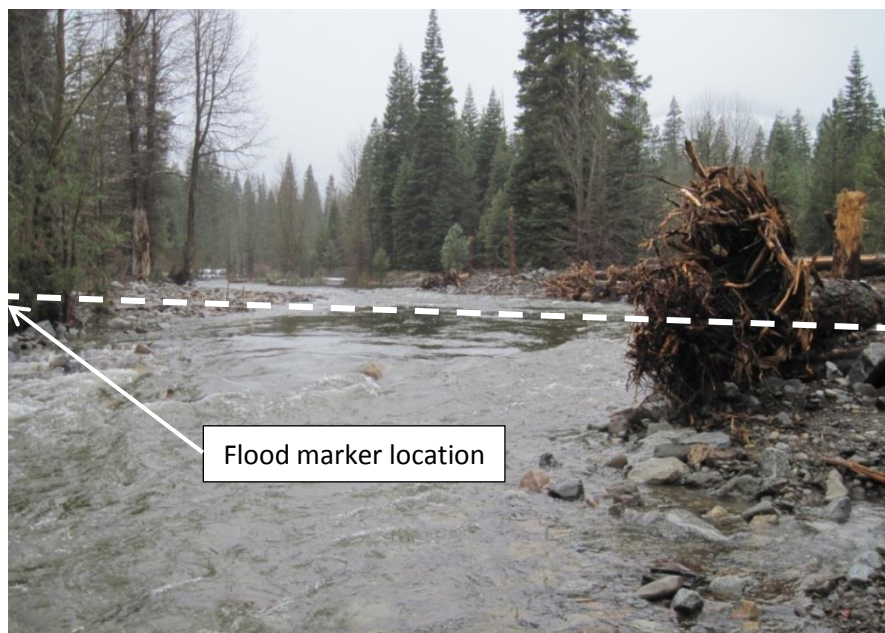
Flood evidence (flood detritus hanging off stream side vegetation identified after winter) established the flood level (Figure 2) and Swanson's flood numbers suggest the project area discharge ranged between 700 to 900 CFS, estimated to be an 8 to 10 year rain-on-snow type flood. Site inspection on December 5th suggests that flow was split between the south and north channels with the majority of flow probably going down the larger southern branch. Another minor high elevation rain storm on December 5th caused a 250 CFS flow at the USGS gage. Project area discharge was roughly 150 CFS and about 60 percent of capacity.

Figure 2 - 5 December photo showing approximate water level of 3 December flood.

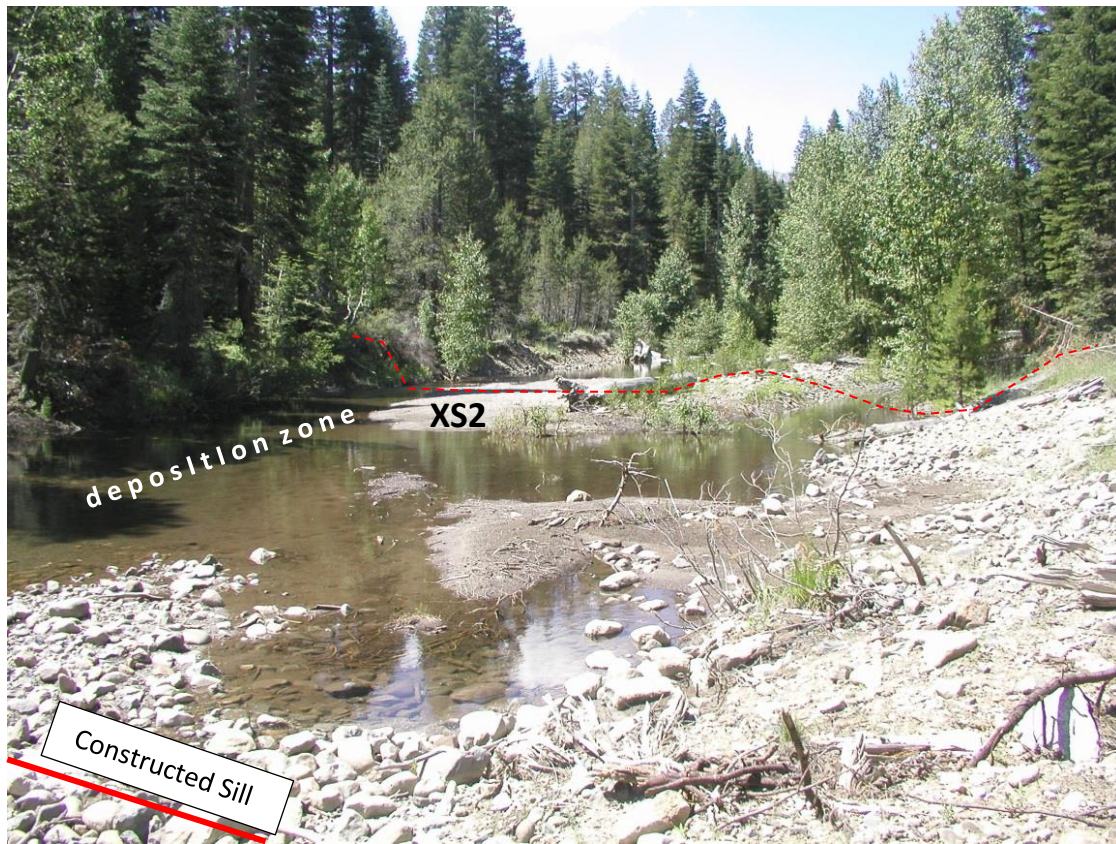
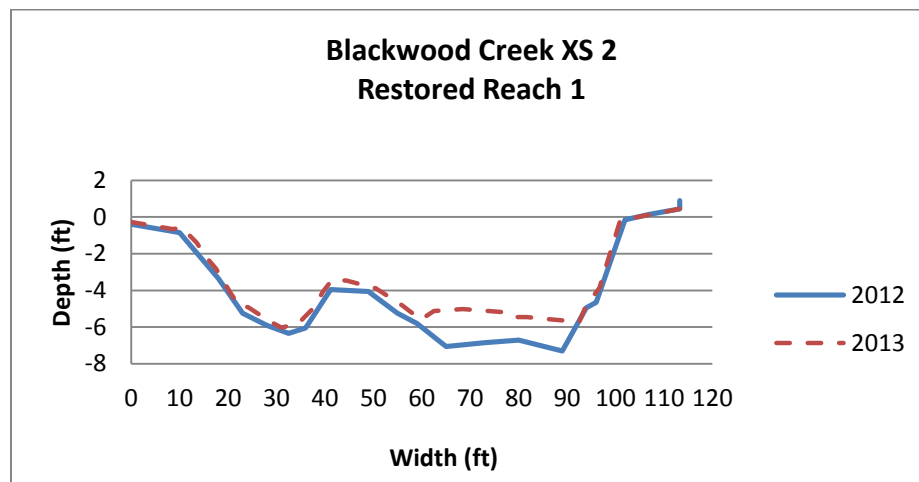
Interestingly, most of the sediment deposition and bar building did not occur in the project area, but happened along a 300' section of the southern branch just above the project. The photo and cross section (Figure 4) in this depositional zone recorded the scale of the deposition (fines, sand, and gravels) as the stream backwatered upstream of the uppermost constructed weir. The sill (boulder grade control structure) was constructed to a higher elevation than existing channel just upstream. Backwatering (expected to occur) reduced water velocity causing sediments to fall out of the water column and fill in the channel. We believe this occurred on the receding limb of 3 December flood.

Figure 4 – July 30, 2013 photo and cross section changes in deposition zone upstream of the newly constructed stream segment on the southern fork of the creek. Photo taken near constructed sill on left bank from looking upstream at the cross section area. Cross section plot orientation is opposite of the photo.

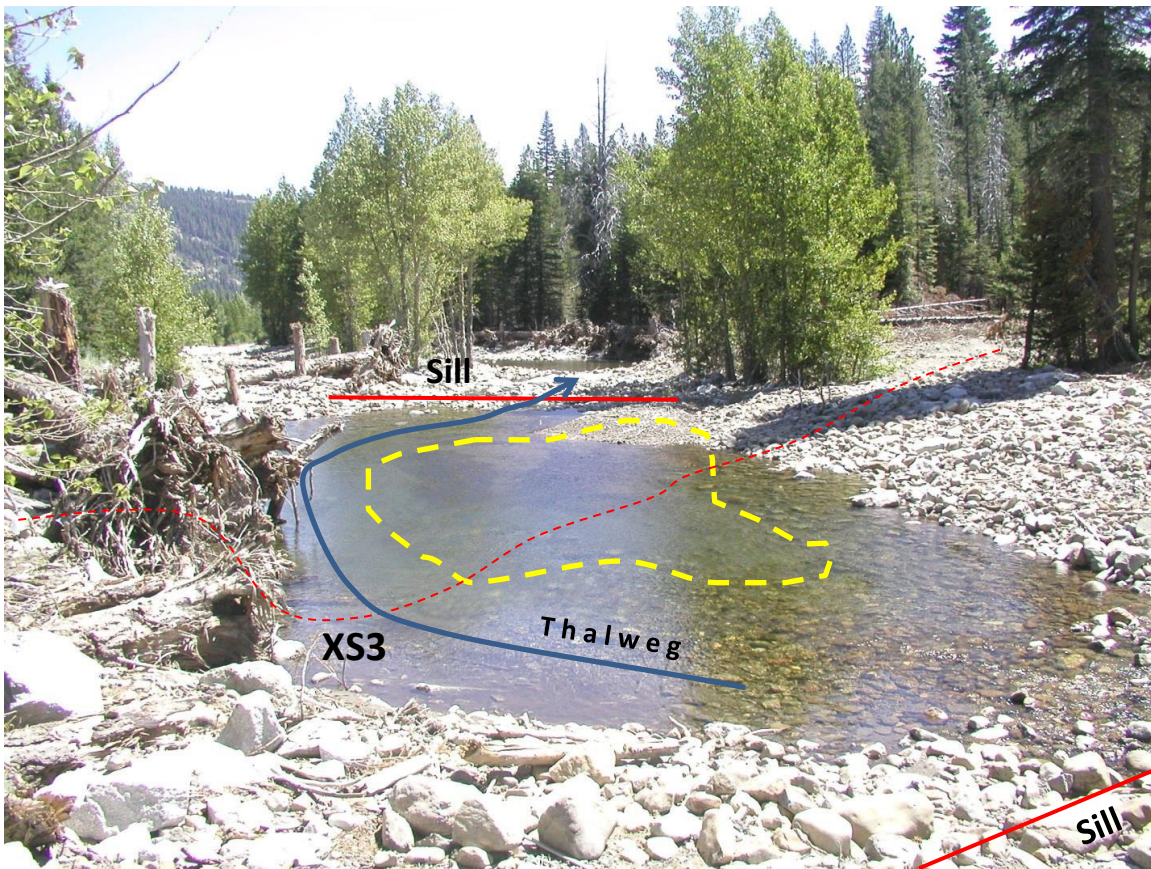
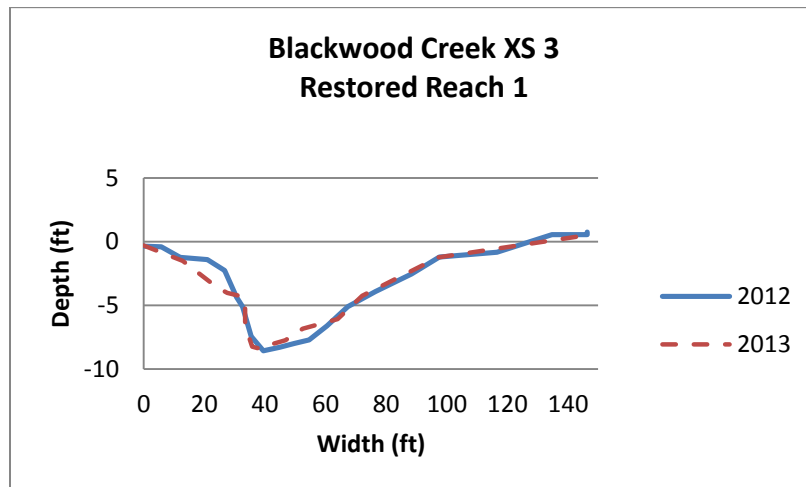
Project area deposition occurred on point bars and channel margins in expected locations. Photo and cross section (Figure 5) show the largest deposit in the project area; sediment (fines, sand, and fine gravels) deposited to a depth of 0.1 to 3 feet. This deposit probably formed due to backwatering caused by a constructed sill located just downstream.

Figure 5 – July 30, 2013 Photo and cross section in deposition zone on reconstructed southern fork of the creek. Photo taken near constructed sill on left bank looking downstream cross section area and deposit; dashed polygon outlines this deposit next to the channel thalweg, the deepest part of the channel.

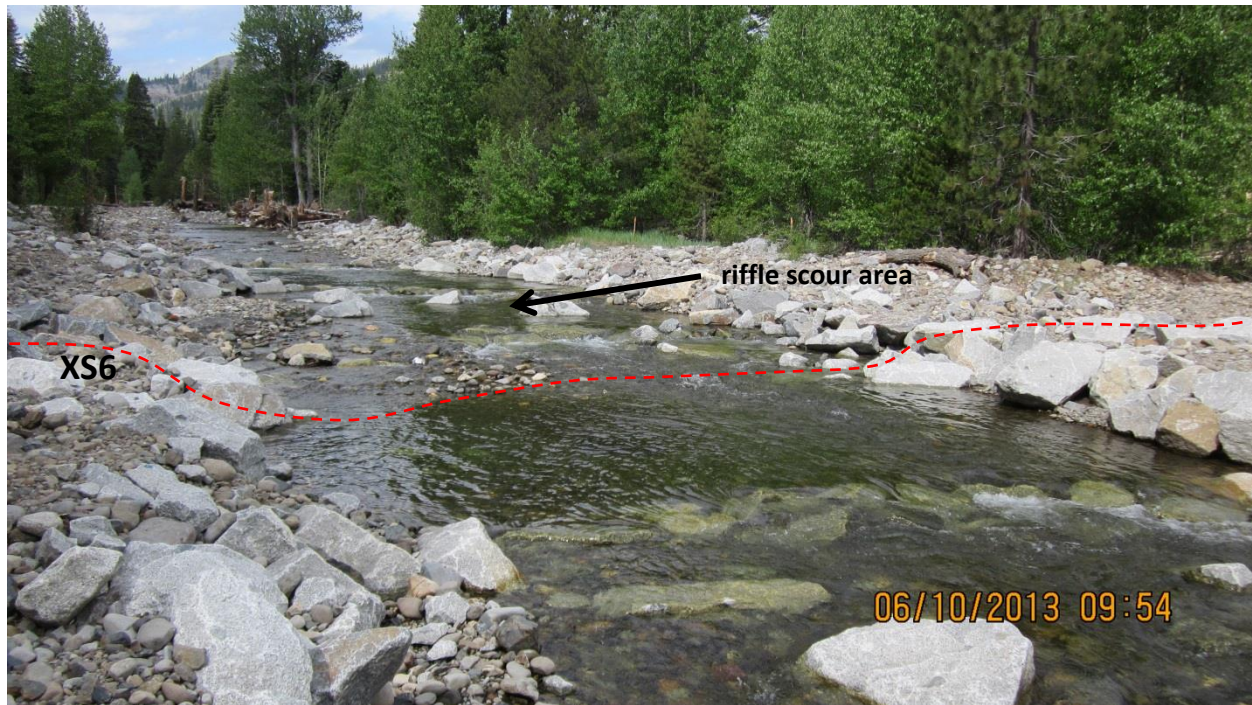
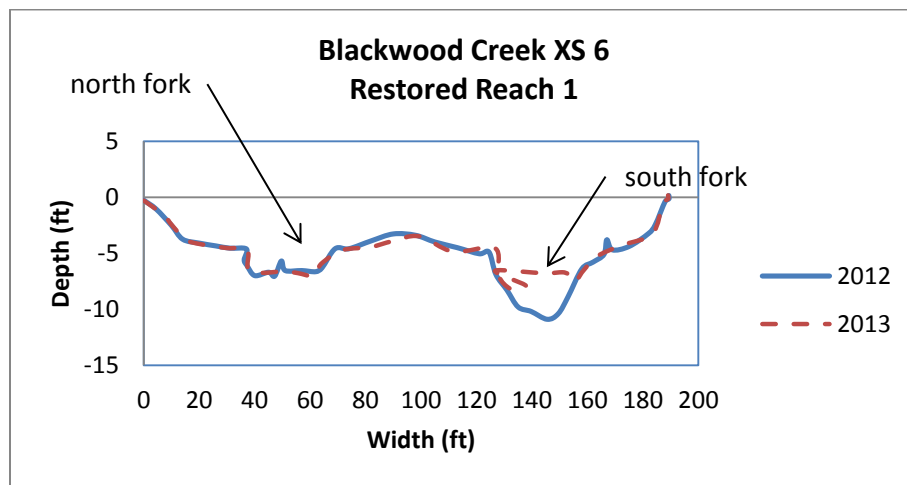
Scour did occur at one location in the project area. The photo and cross section (Figure 6) shows the pool being partially filled in by gravelly bed load sediment. The source of this material appeared to be the riffle just upstream. Scouring to a depth of a foot occurred within this roughly 30' section of the south fork. The cross section captures pool infilling. We believe the scour occurred during the December 3rd flood. The flood was of such a short duration that sediment transport within the project was localized, and with the backwatering upstream limiting the movement of replacement sediments, it resulted in this riffle scour and pool deposition pattern.

Figure 6 – June 10, 2013 photo of riffle scour and pool deposition on southern fork of the creek. Photo taken looking upstream. Cross section plot orientation is opposite of the photo.

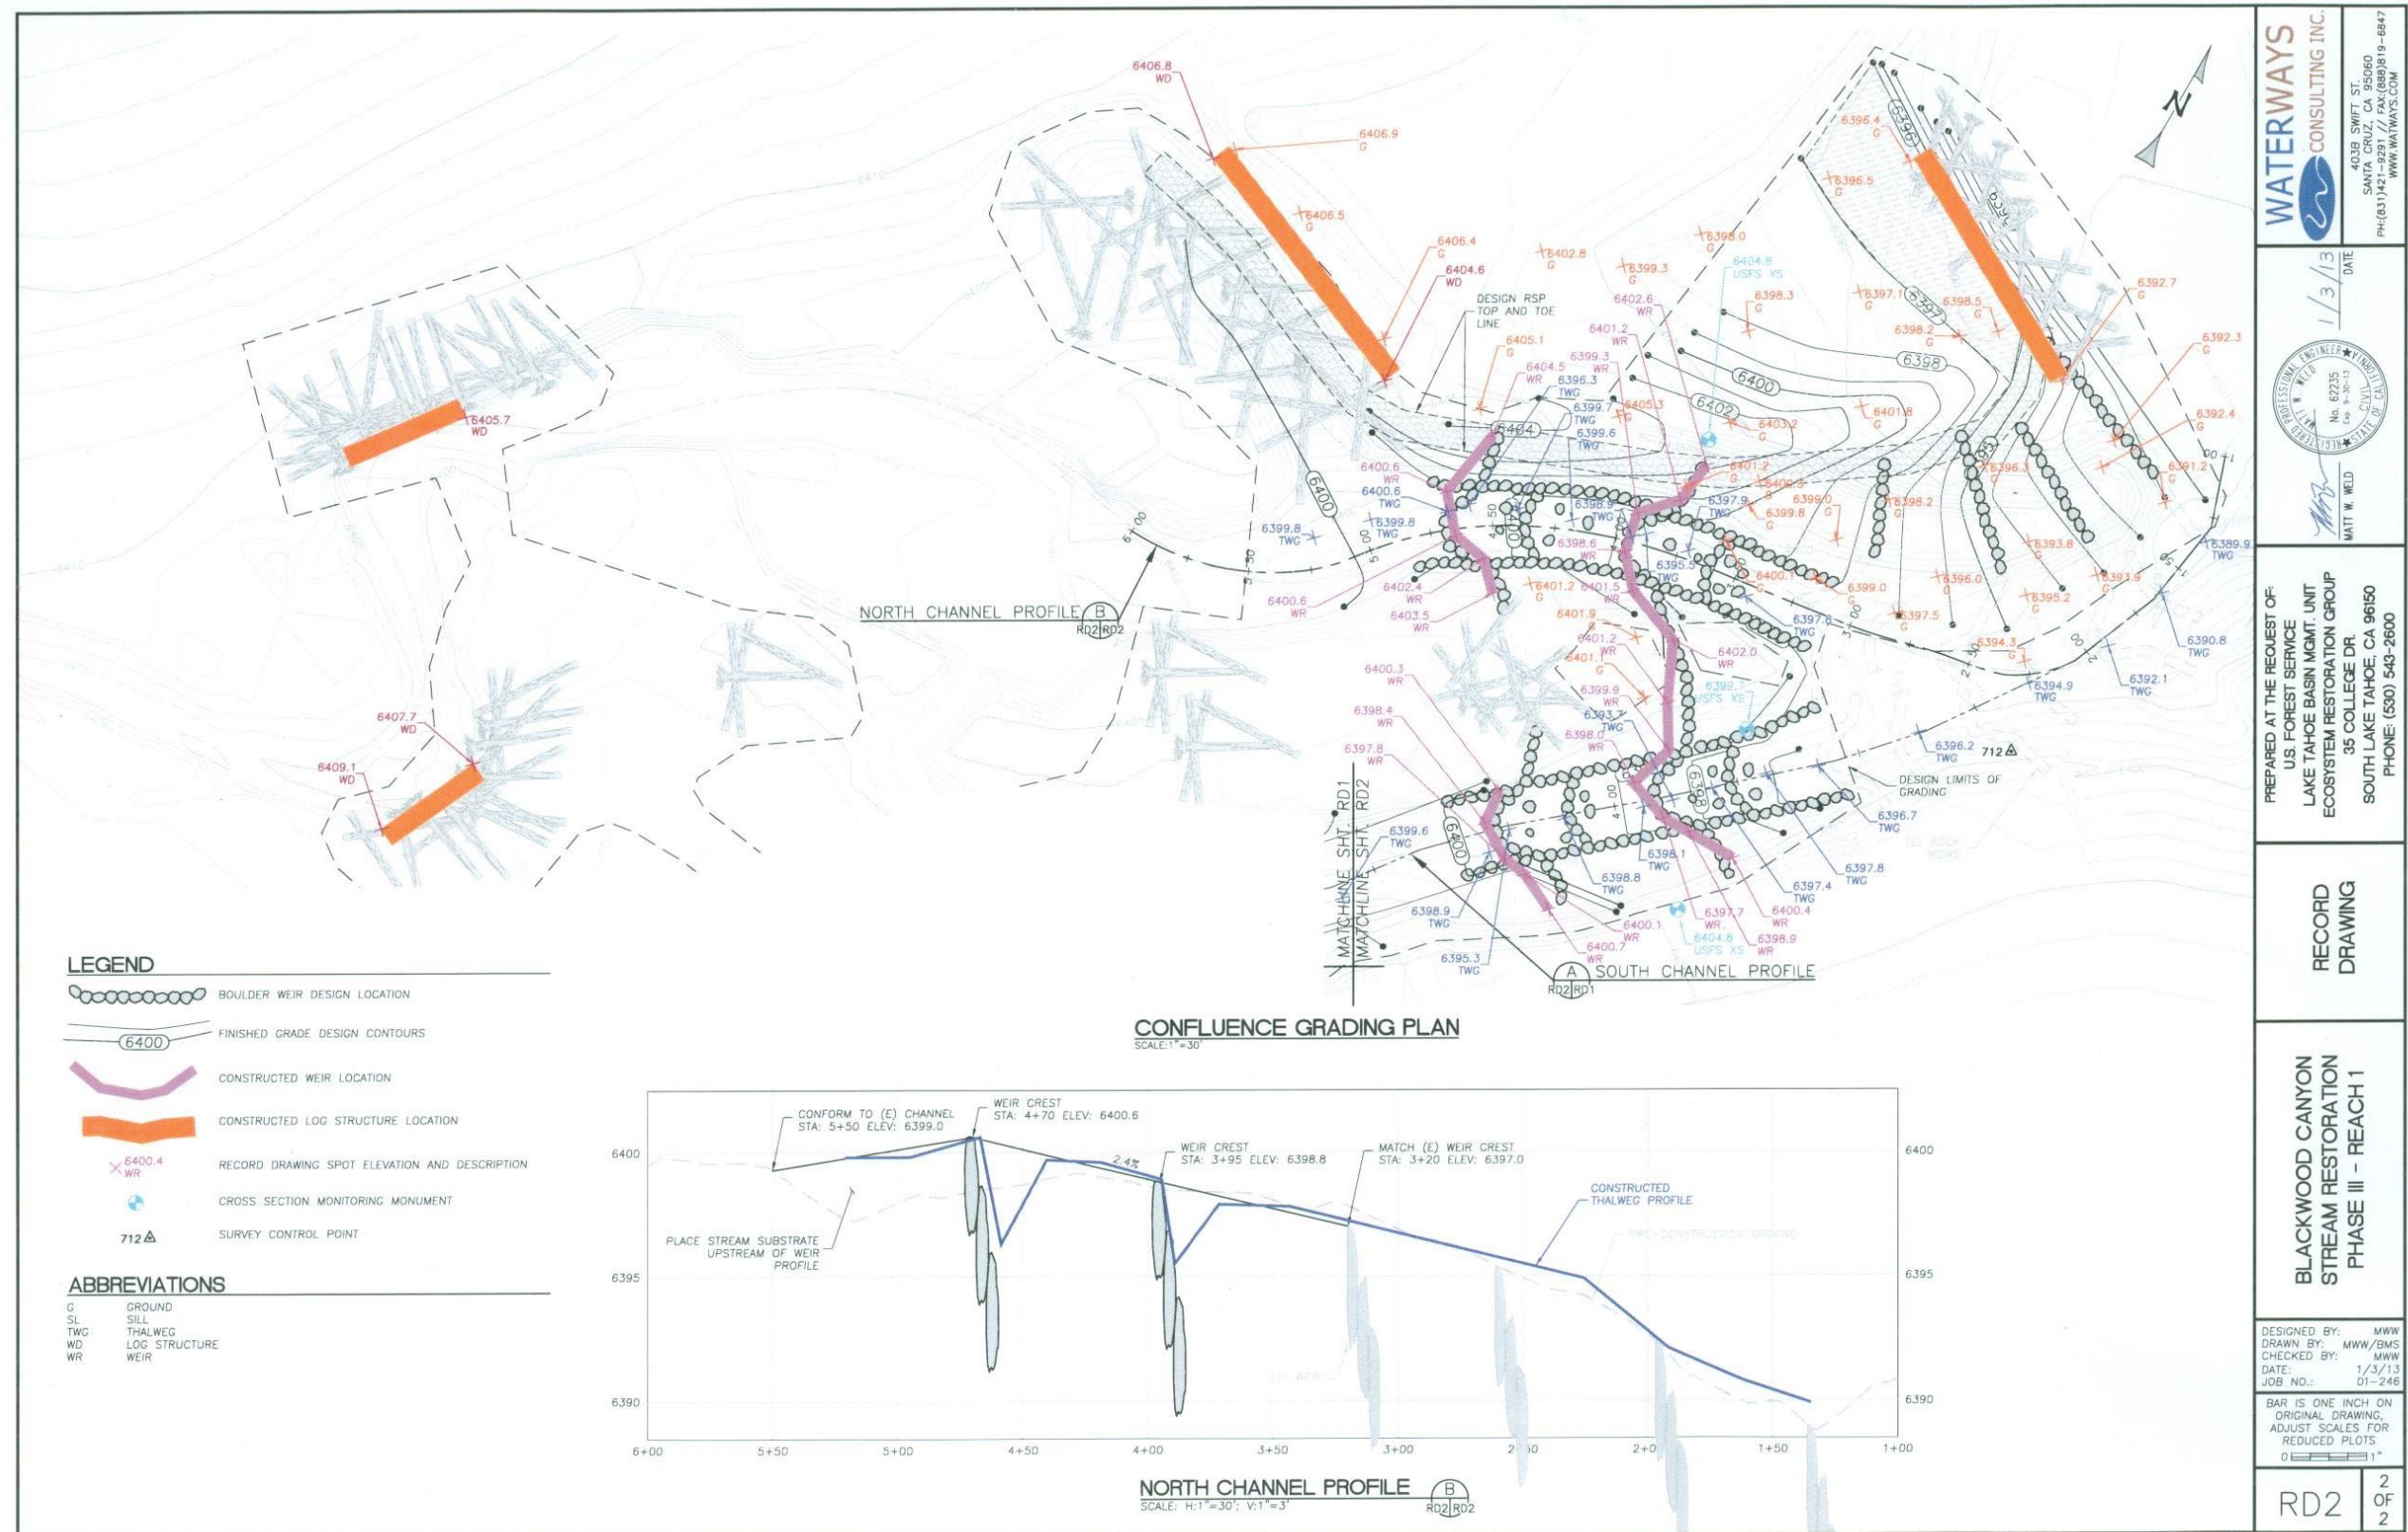
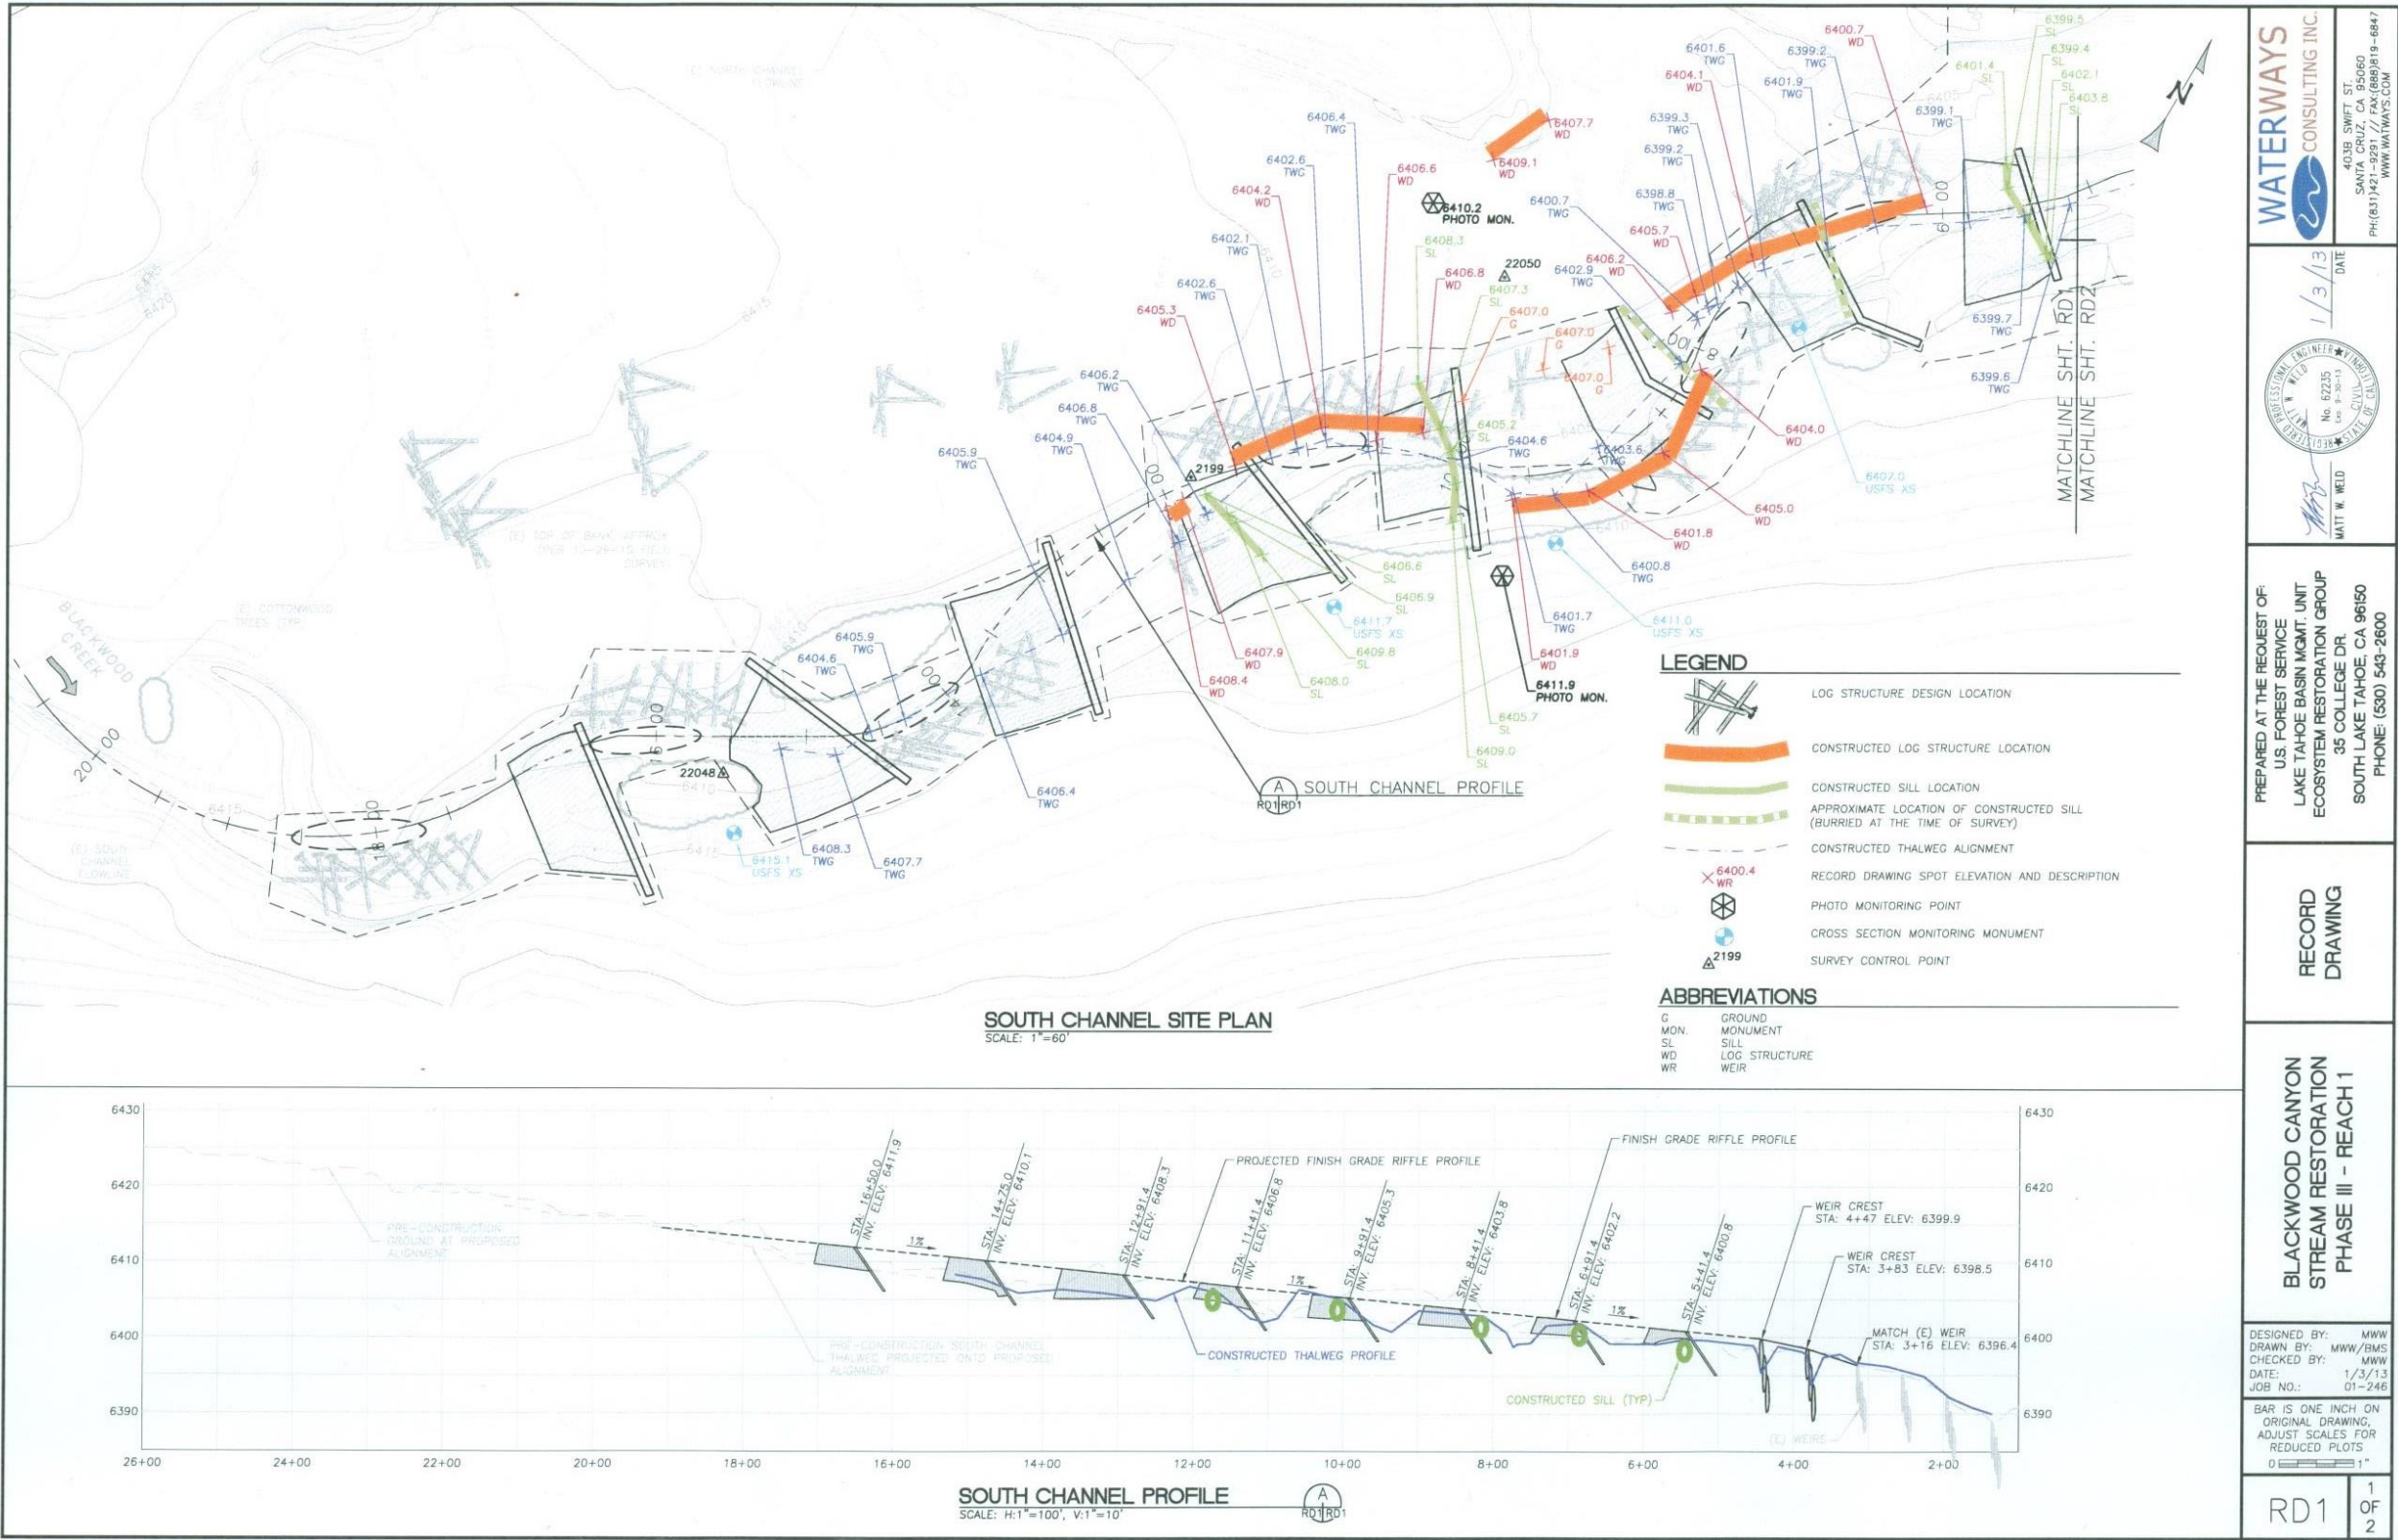
RECORD
DRAWING

As can be seen from the Attachment A, the constructed work generally conforms to the drawings and meets the intent of the design.

Due to schedule constraints, the upstream end of the work was left incomplete, with the three most upstream weirs omitted from the work. However, the constructed portions of the project will be unaffected by this omission.

The measured profiles indicate that some of the riffle crests were constructed below design grade. The construction of the sills was guided by a sufficient amount of staking points, therefore, the discrepancy between measured and design grades is most likely the result of data points recorded at low points on the cross section (e.g., between large boulders), and may not be representative of the average sill elevation or hydraulic performance.

The work should be closely monitored for the first five years following construction and inspected immediately after large storm events (5-year or greater recurrence interval) to evaluate success and adaptively manage to optimize performance. Monitoring efforts should, at a minimum, include cross section surveys tied to the project's original datum to evaluate trends in bed level evolution.
